Yorkshire Peat Partnership

WORKS MONITORING REPORT

May 2017

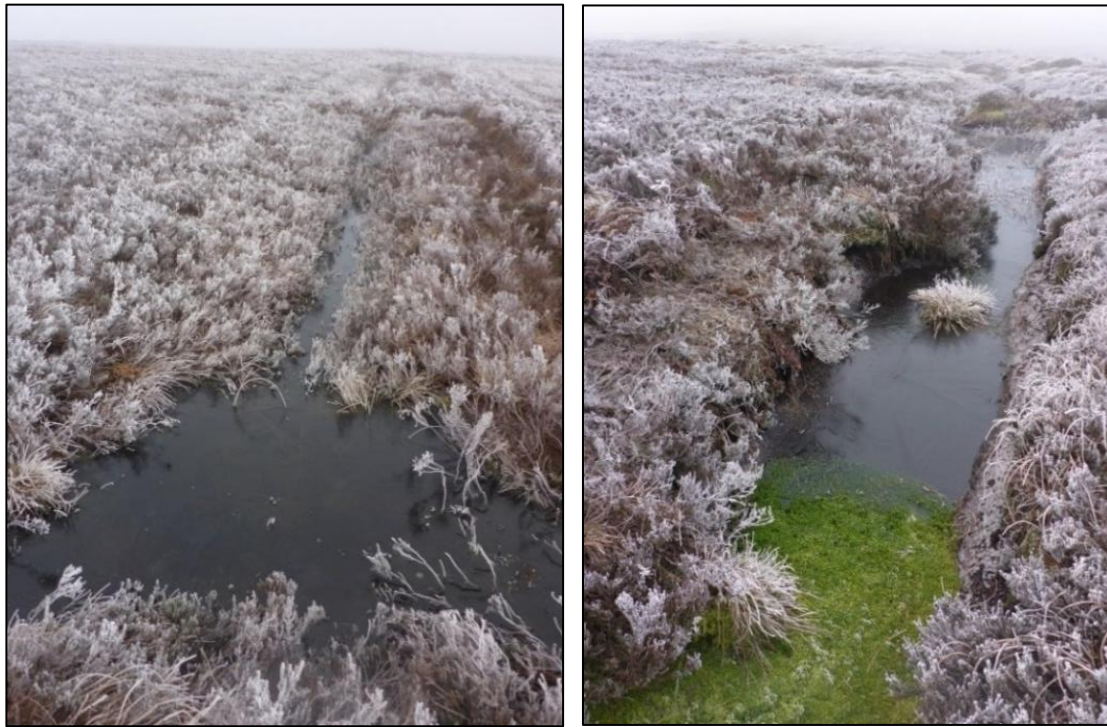
Figure 3: Gouthwaite Moor, 2015: a reprofiled grip (left) and a non-reprofiled grip (right).

The practice of reprofiling was common in the early years of YPP's restoration work but was recently discontinued following evidence that it may increase the release of methane (Green, S., Boardman, C., Baird, A., 2011). However, through the monitoring process a number of interesting differences between reprofiled and non-reprofiled grips began to emerge which may benefit from a more detailed investigation. Visually, the reprofiled grips appear to have revegetated faster and are potentially less vulnerable to erosion than their non-reprofiled counterparts (Figure 3 & 4).

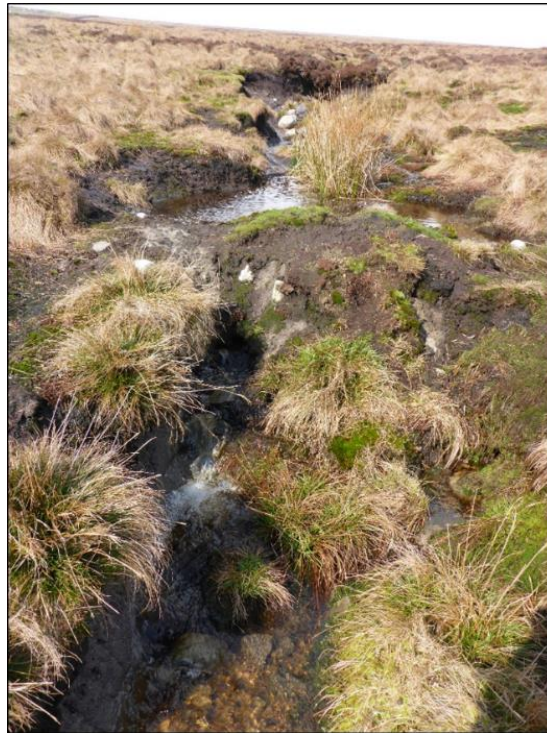
Erosion of peat dams and restored grips was found to be a particular problem on sites with steeper gradients and higher run-off such as The Preserves (Figure 5 & 6).

Figure 5: Erosion of previously restored grip and peat dam, The Preserves, 2017

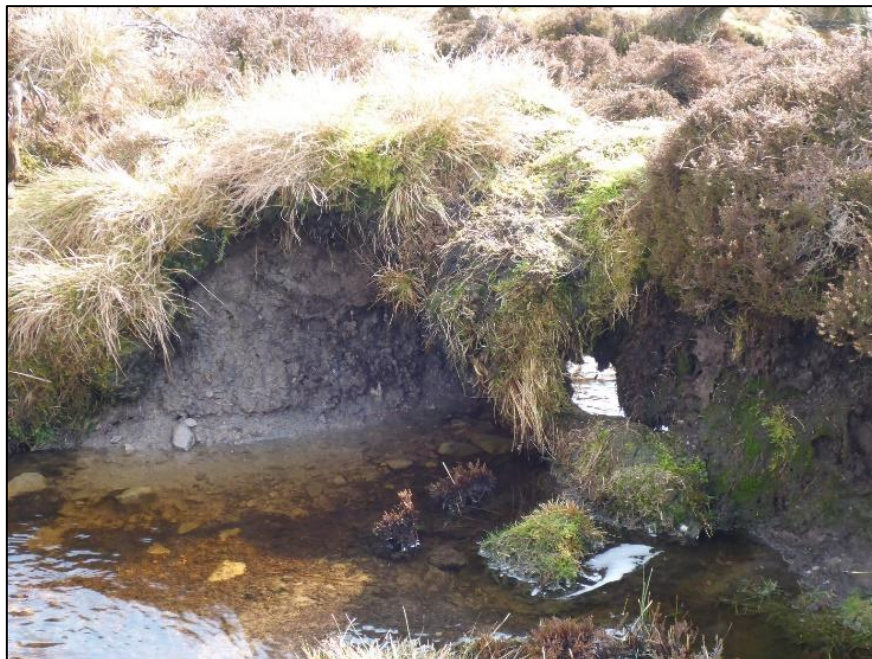
Here only 77% of peat dams were intact compared with an overall average across the sites of 95%. At the time of the site visit water run-off was high and flowed unimpeded across the steeper parts of the moor, subjecting dams lower down to a great deal of force. Clearly, over time this has led to problems including dams being undermined by flowing water (Figure 6).

Figure 6: Eroded peat dam on The Preserves, 2017

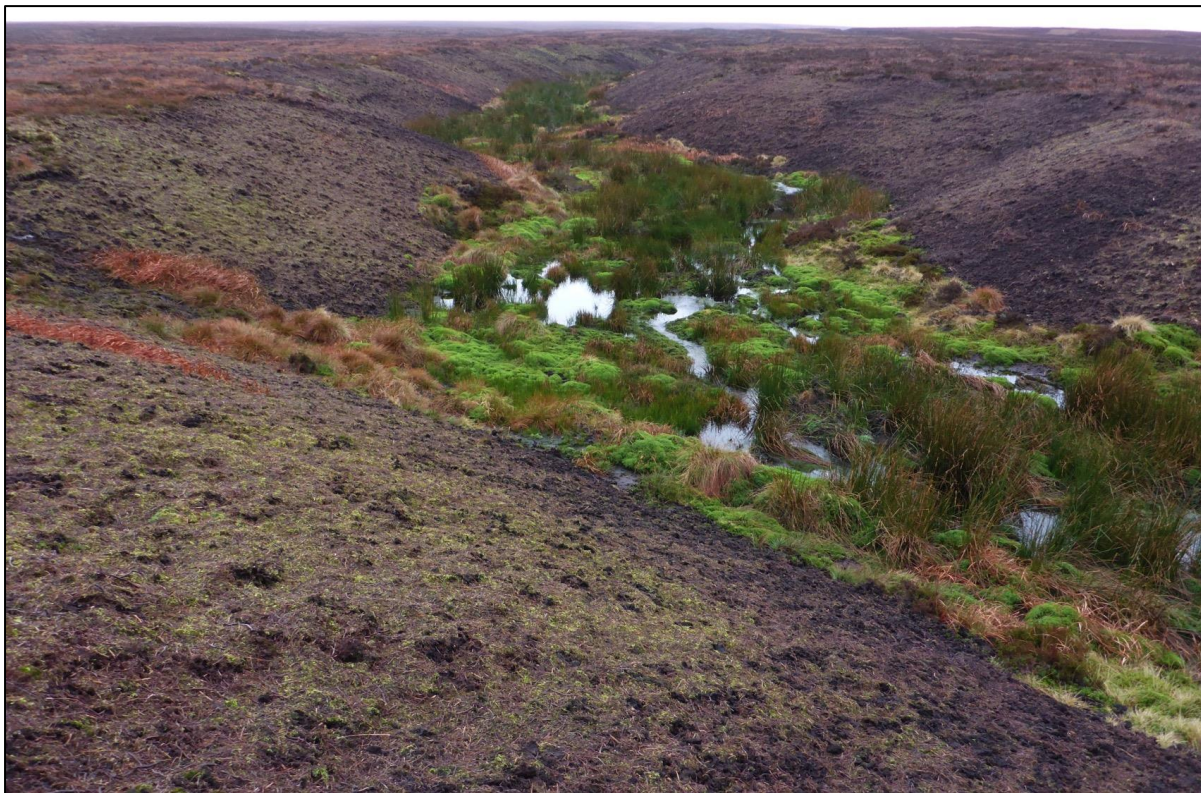
Many of the revegetated sites where low vegetation cover was recorded were restored using techniques that have since been modified. Applications of brash, dwarf seed and 'nurse' grasses have been increased and less suitable lowland grass species have been replaced by upland varieties better adapted to local conditions. Cotton grass plugs were also introduced last winter, targeting wetter areas. Although it is not possible to predict the success of the revegetation from recent work using these updated techniques, the first signs are promising (Figure 13).

Figure 13: Ramsgill (2017) reprofiled and revegetated gully sides, one year after works completion.
