Yorkshire Peat Partnership

WORKS MONITORING REPORT

May 2017

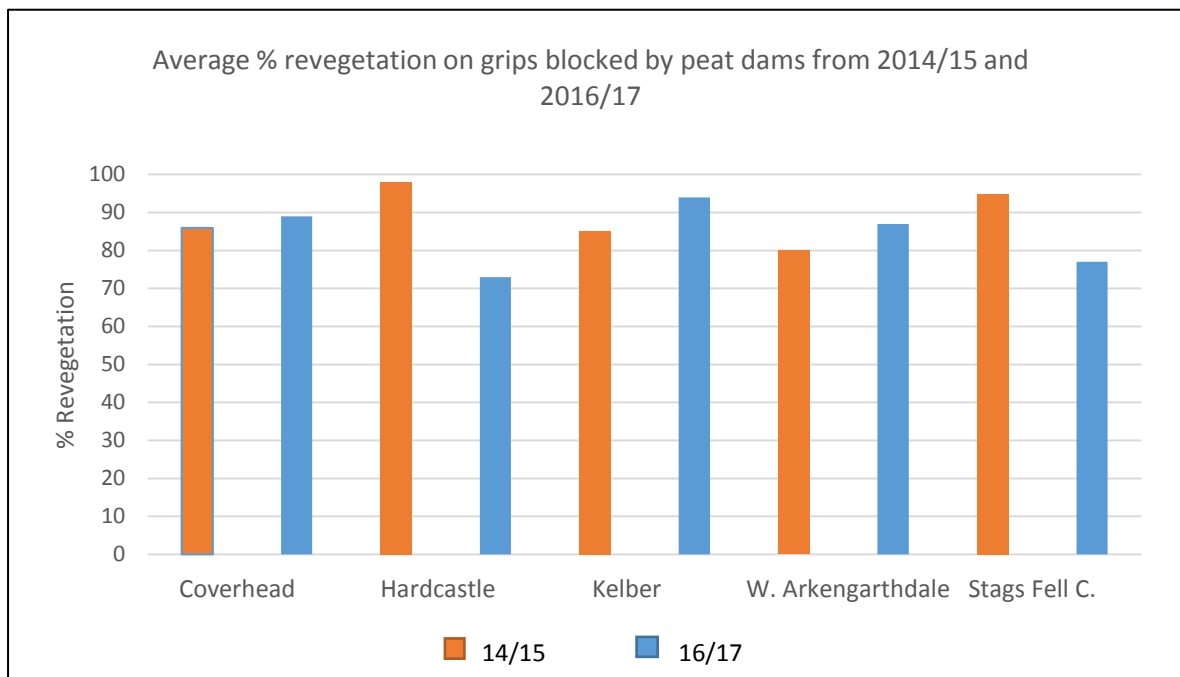
Figure 7: Data comparing vegetation cover from sites monitored in 2014/15 and 2016/17.

Out of the five sites average vegetation cover has gone up on three (Coverhead, Kelber and West Arkengarthdale) but down on Hardcastle and Stags Fell Central (Figure 7). Part of the decline on Hardcastle could have been due to recent burning over the features being monitored. Also, the data from 2014/15 for Stags Fell had been gathered after heavy snow, so may have been less accurate.

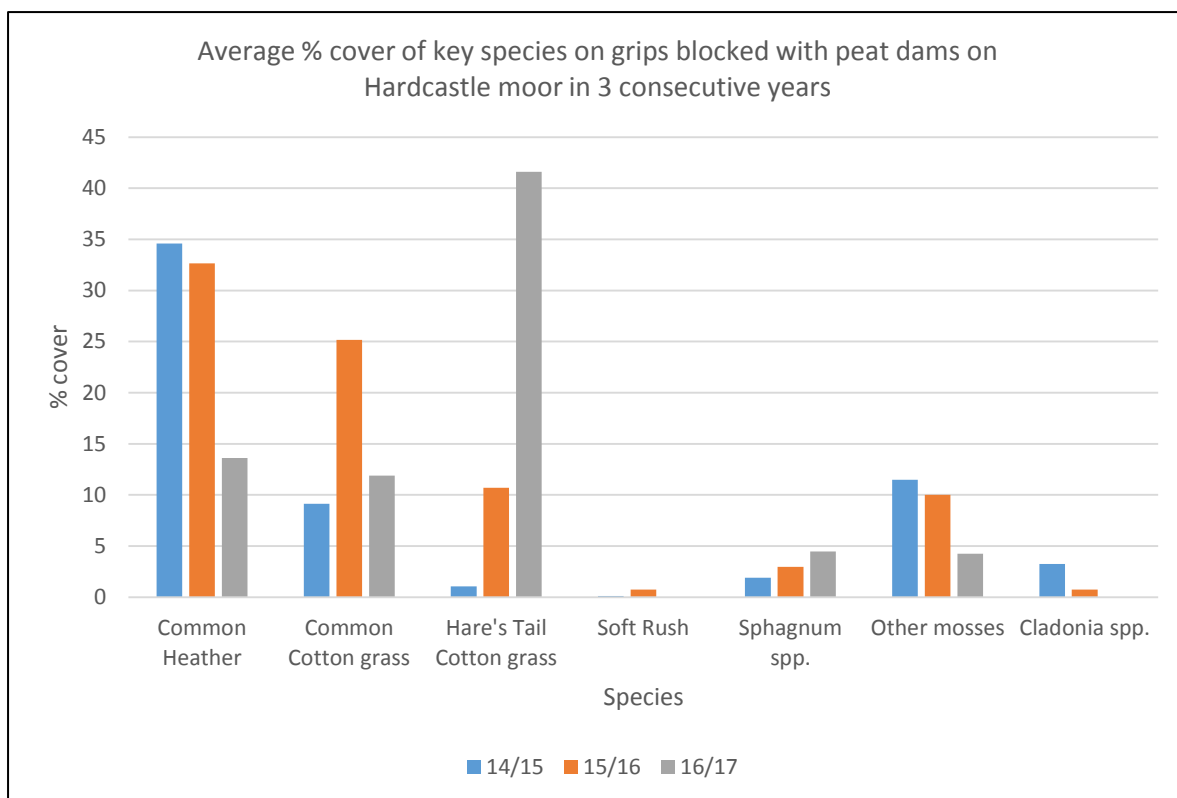
Figure 8: Data comparing percentage of species cover on Hardcastle moor monitored in 2014/15, 2015/16 and 2016/17.

Hardcastle (Figure 8) has particularly interesting changes with no records of Soft Rush *Juncus effusus*; a decline in grasses, mosses, *Cladonia*, *Sphagnum palustre* and *S. fallax*. This all points to a reduction in water flow and an increase in acidity. To substantiate this trend, these species are being replaced by new blanket bog species including cranberry *Vaccinium oxycoccos*, and several sphagnum species including *S. subnitens* and *S. magellanicum*. All of this is showing a very positive shift to blanket bog communities.

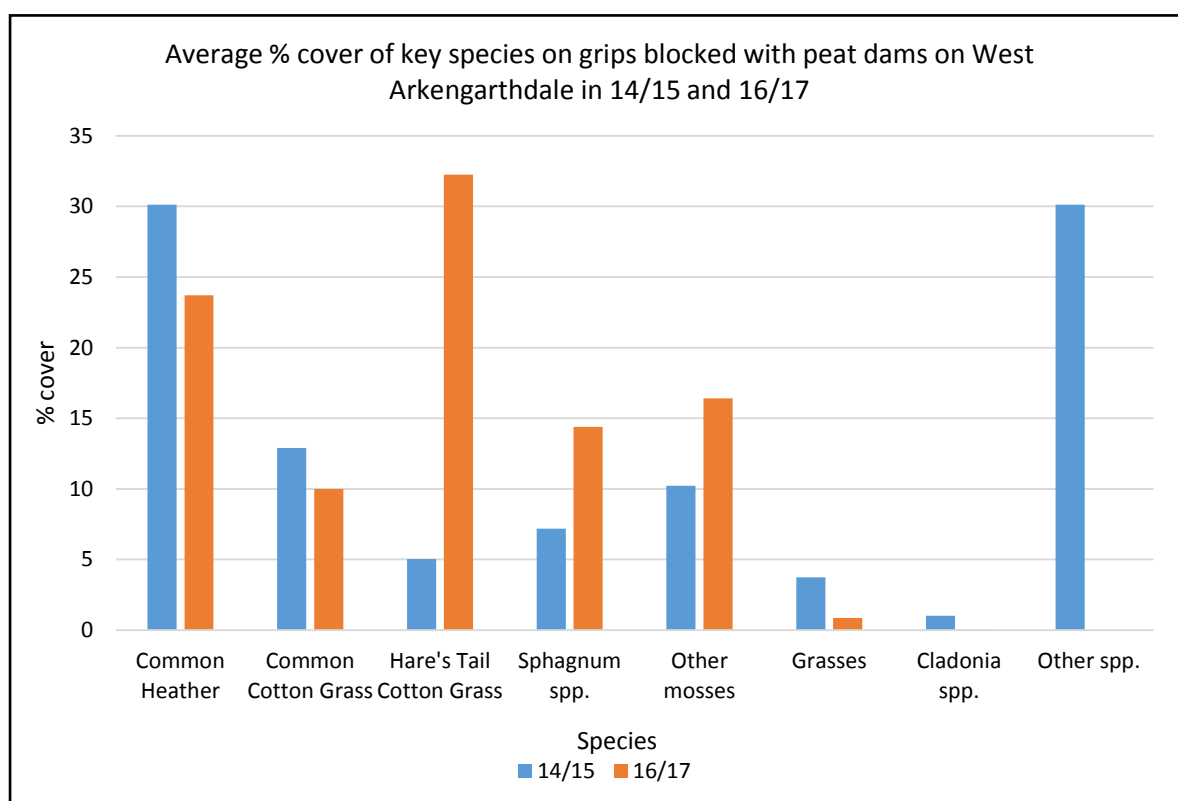
Figure 9: Data comparing percentage of species cover on West Arkengarthdale monitored in 2014/15 and 2016/17.

There was no data for species on Stags Fell Central due to the snow cover at the time of monitoring in 2015, but on the other 4 sites percentage cover of Common Heather *Calluna vulgaris* has decreased; Hare's Tail Cotton-grass *Eriophorum vaginatum* has increased substantially and sphagnum species have also shown a steady rise.

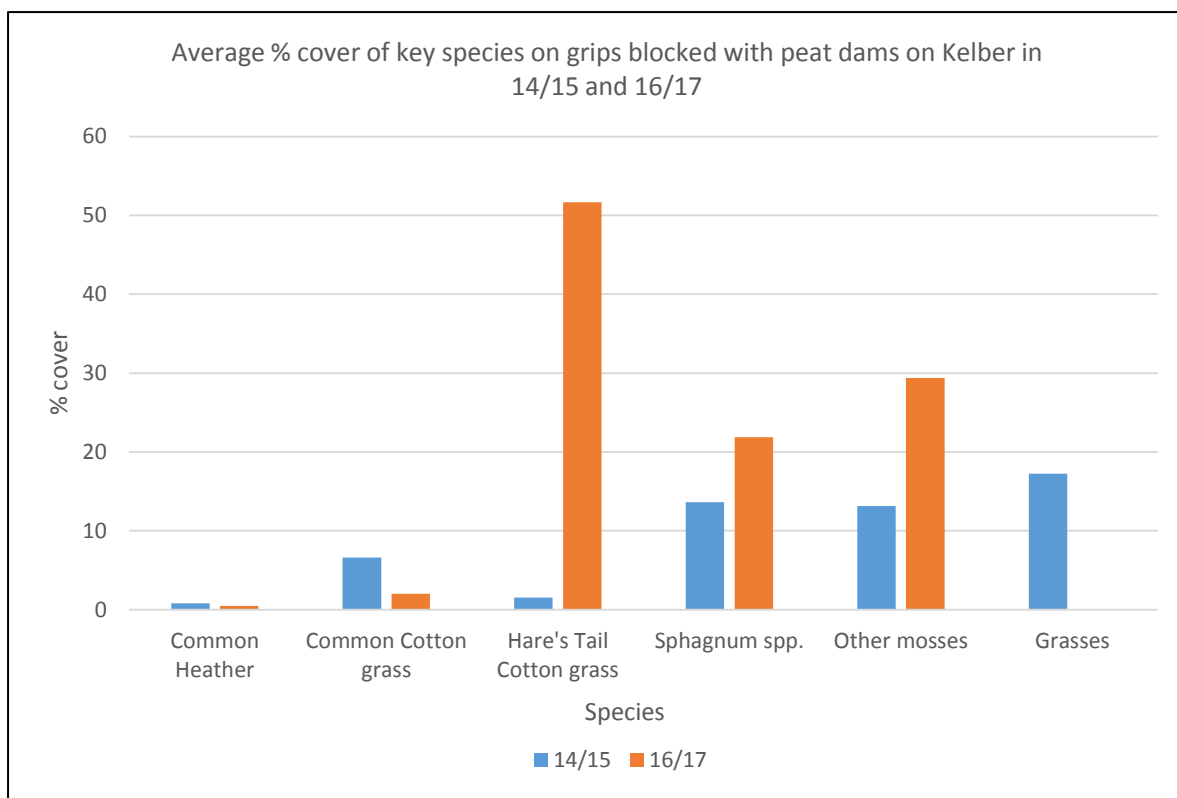
Figure 10: Data comparing percentage of species cover on Kelber moor monitored in 2014/15 and 2016/17.

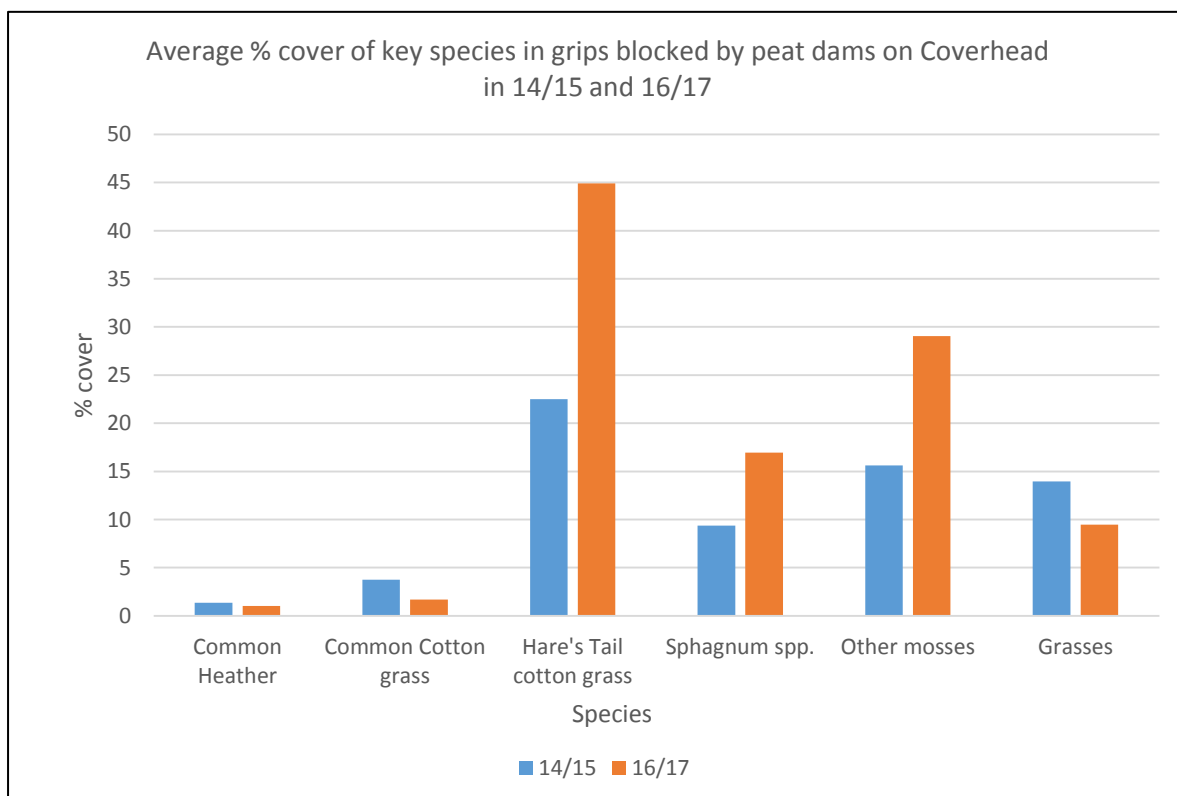
Figure 11: Data comparing percentage of species cover on Coverhead monitored in 2014/15 and 2016/17.
